Application: Protect Furnace Cover in the Steel Factory

User: Jinan Steel Factory

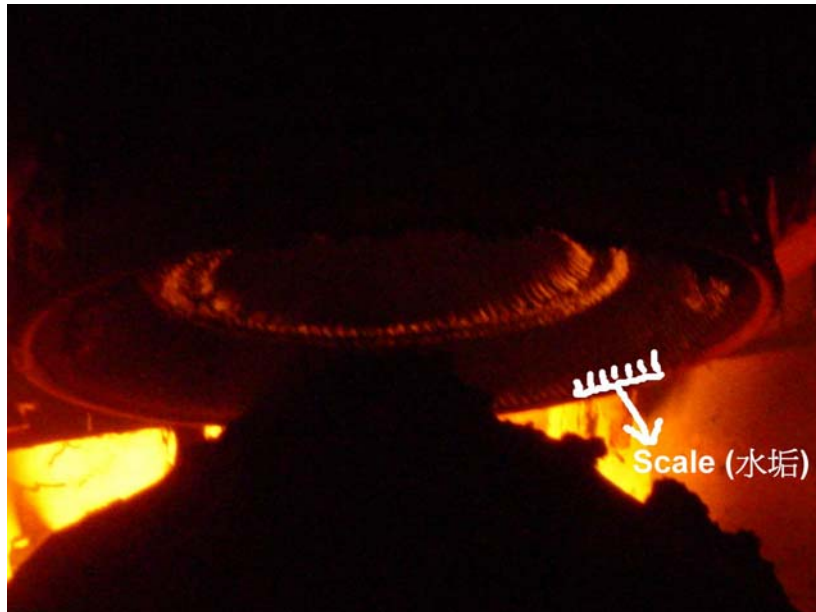
Picture (A)

The steel furnace cover, shown in picture A, has 160 pipes at 3.8mm diameter inside the cover. Temperature at the furnace is at 1800 . Water passed through these pipes to reduce the heat. When hard water was used, pipes might be blocked because of scale. Production had to be stopped and the blocked pipes had to be by-passed. It was a routine practice to stop production every week to by-pass the blocked pipes. It estimated that it cost more than US\$6,000 for each interruption in production. In addition, a new cover had to be installed every 6 months. Water hardness used in the factory is at 320-380ppm.

There were three production lines in the factory and one *HydroFLOW* C-160 was installed for each line. After 6 months of installation, two production lines never had to be stopped because of scale blockage. The third line was only stopped twice during the same period.
