1.3 Weatherford Scaling Tests

**CLEARWELL SCALE INHIBITION
RESEARCH STUDY**

Hycal Energy Research Laboratories Ltd.

March 11, 2005

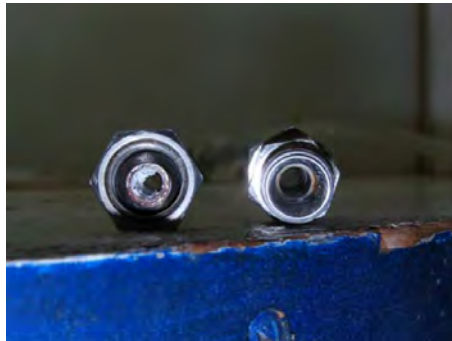
Figure 1.3: The scaling of an untreated pipe (left) compared to a pipe treated with Hydropath (right) (page 10).

The difference in the amount of scale formed on the pipes with and without Hydropath was observed visually. Not only was there significantly more scale on the untreated system, but it could easily be seen that the scale was hard and required manual scraping, unlike in the treated system, where the deposits were soft, powder-like and easily brushed away.

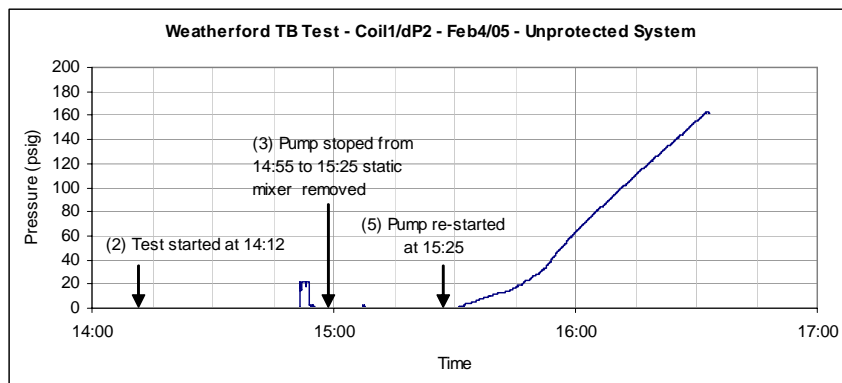
The first test was not treated with the Hydropath unit and pressure build-up was observed in seven minutes, resulting in plugging of the system with barium sulfate scale (see pressure profile of the upstream heated coil below). It should be noted that the test was attempted twice. There was a packed static mixer in-line initially which plugged. The static mixer was removed and the test was restarted. It took a total of 1100 psig pressure using distilled water to flow through the plug once it was established.

Without treatment, the pipe became blocked in just seven minutes (test 1A, page 4). The blockage was solid and it took a high pressure to clear it (page 4). The Hydropath unit used was shown to cause the scale to form in suspension rather than on the surfaces of the tubes. In tests 1 and 2, the

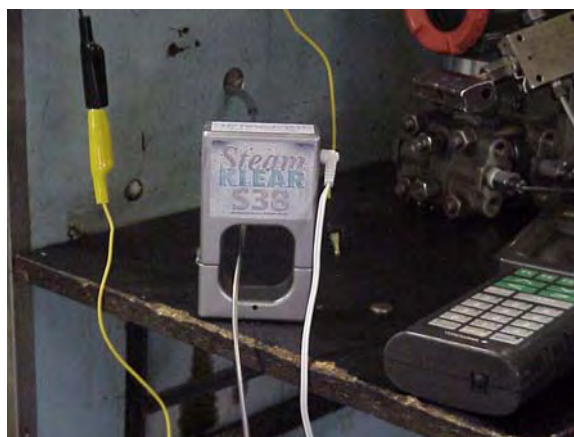
This test was run identically to the untreated test with the exception that the Clearwell Hydropath unit was placed in line between the tube block coil inside the oven and the tube block coil outside the oven (see photo below).

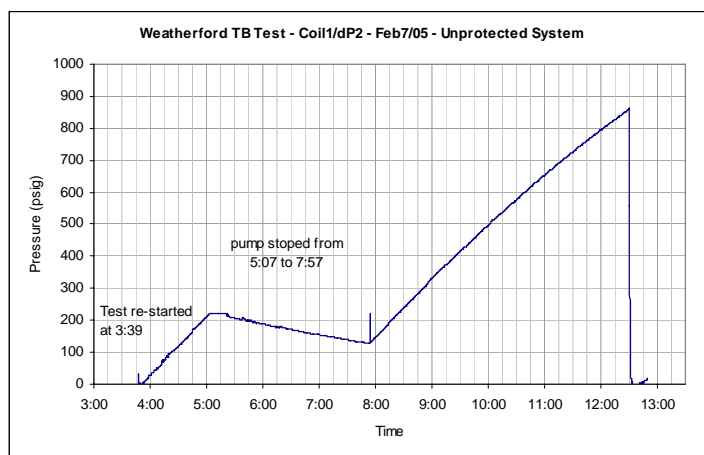
The system was shut-in with the Hydropath unit turned off for 36 hours and then restarted. This time the system plugged off completely. The conclusions that can be drawn from this effect are that the entire flow loop, including the injection brines, were treated and resulted in the seed crystal being formed. When the unit was first shut off, scale did not form due to a lingering effect from the treatment. Only when the system was shut off for 36 hours was the scale able to form as the seed crystals were no longer available in the system.

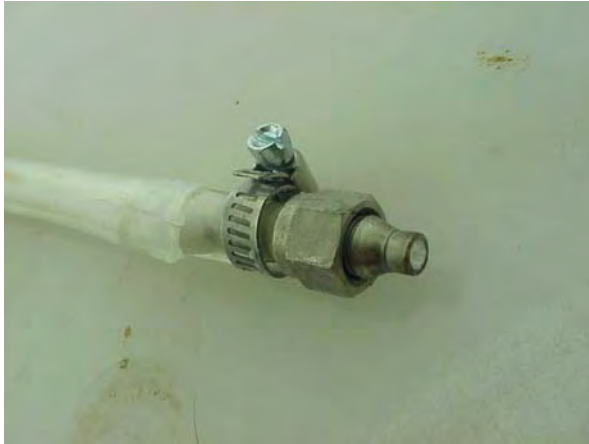
Injection End of Tubing

There was no pressure across the system to speak of (less than 1 psig). This indicated that there was no plugging due to settling. The flow continued for a three-hour period when it became obvious from visual observation in our windowed coupon that scale precipitation had occurred. The system was dismantled and severe scale build-up on the walls of the tubing and in

the injection end was observed (see photographs below). Once the scale had dried, it required mechanical scraping to remove.

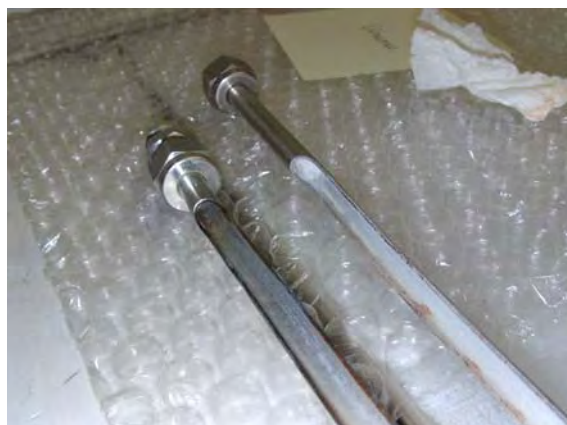
The test was repeated with the Clearwell Hydropath unit in line. The flow was initiated over a three-hour period to replicate the untreated test. Once again, there was very little pressure differential even at the high flow rates. The test was discontinued after three hours and the windowed test coupon was removed and dismantled. The difference in the injection end of the tube and the pipe itself was dramatic. When the tubing was still wet, there did not appear to be any residue or scale formation. Once the tubing dried, there was a thin film of precipitate but it was easily brushed off, indicating that crystals were settling out of the brine film rather than scaling.

**Comparison of Untreated Tube (right)
to Treated Tube (left)**

It is obvious from these photographs that tubing treated with the Clearwell Hydropath unit is cleaner than the untreated tubing.

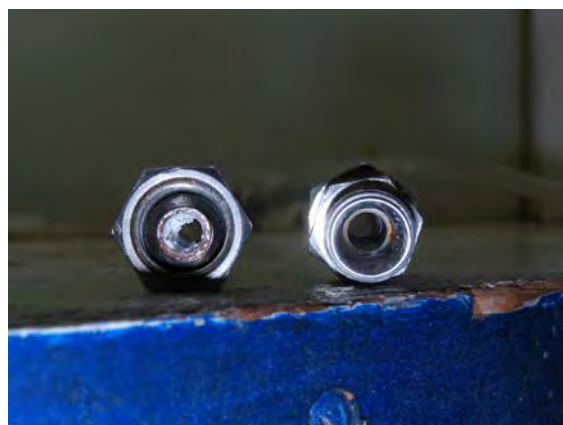
**Untreated Tube (left)
Treated Tube (right)**
